Navajo Abandoned Uranium Mine

Site Screen Report

Mesa V Incline AUM Site

Weston Solutions, Inc.

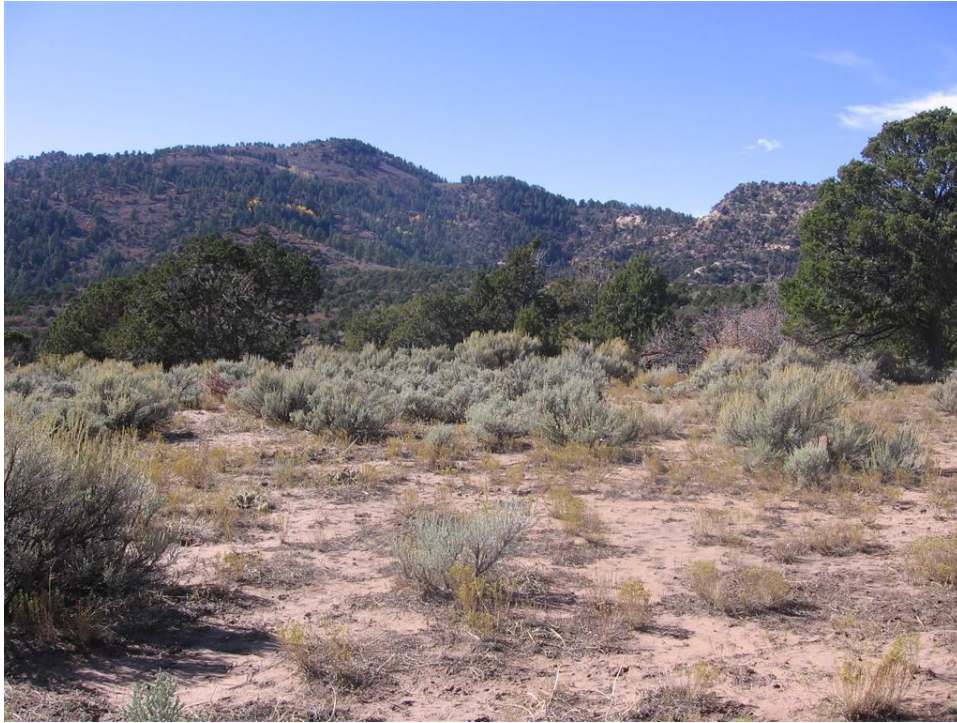
Photo 1. Mine site mesa

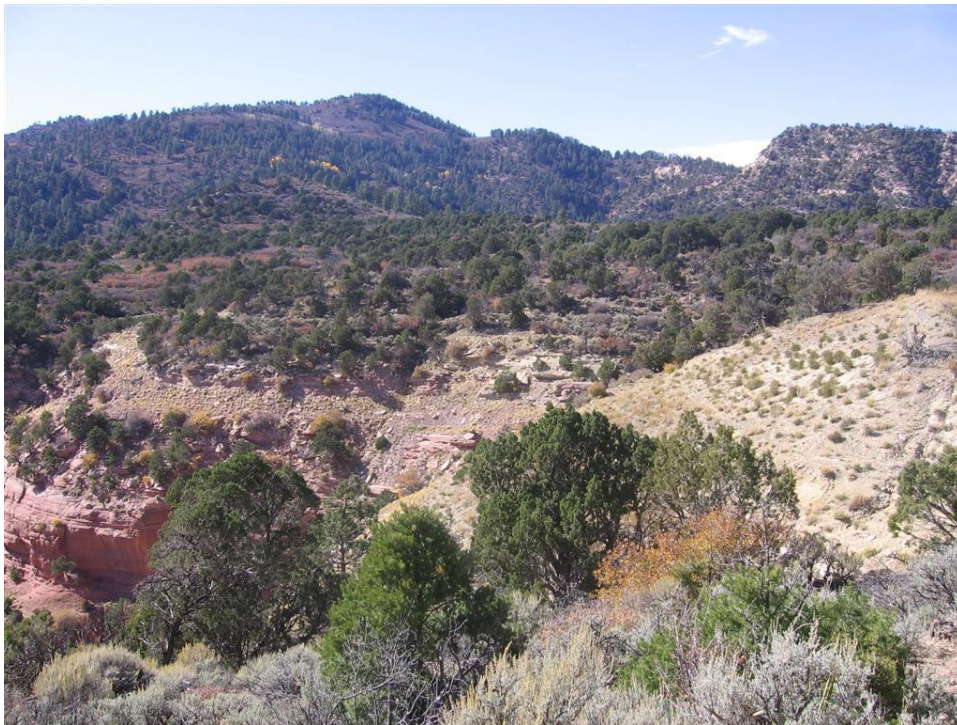
Photo 2. Mine site

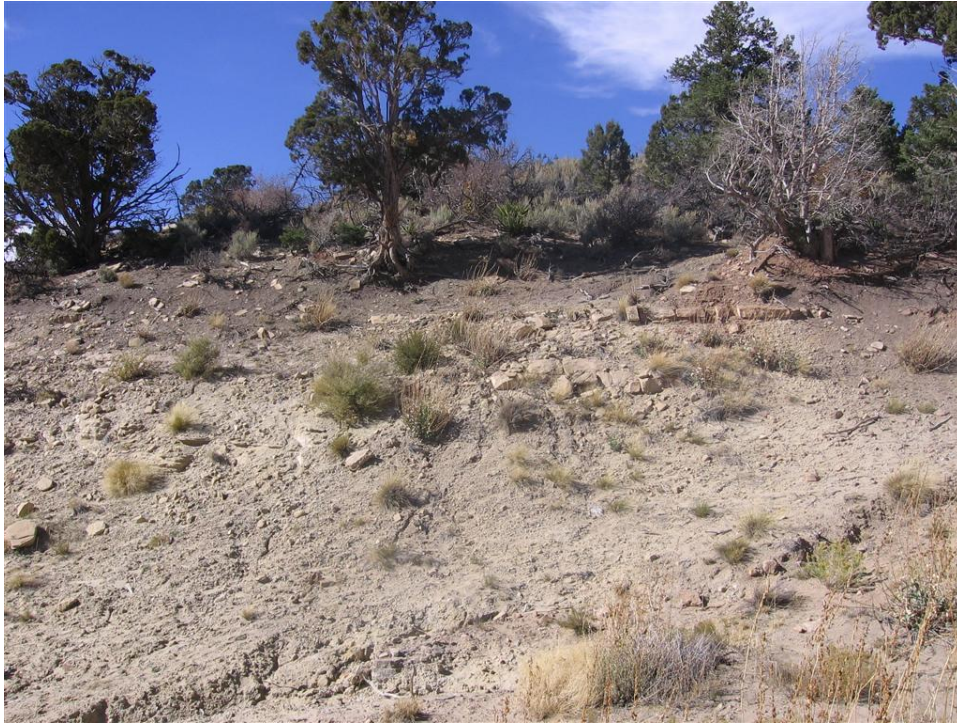
300' x 100' rock pile (w/ soft clay) at southern Mesa V Adit border (#609); more debris with high readings along southern rim of mesa, with a total estimated volume of 5,556 yd³

Photo 3. Waste rock

Unreclaimed waste pile

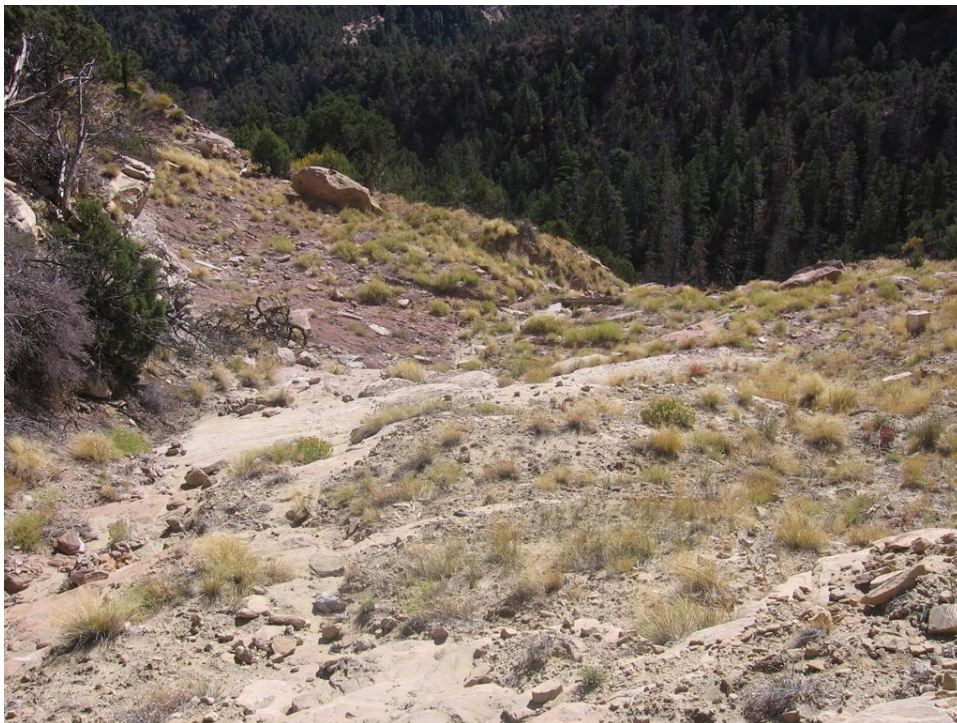
Photo 4. Mine site

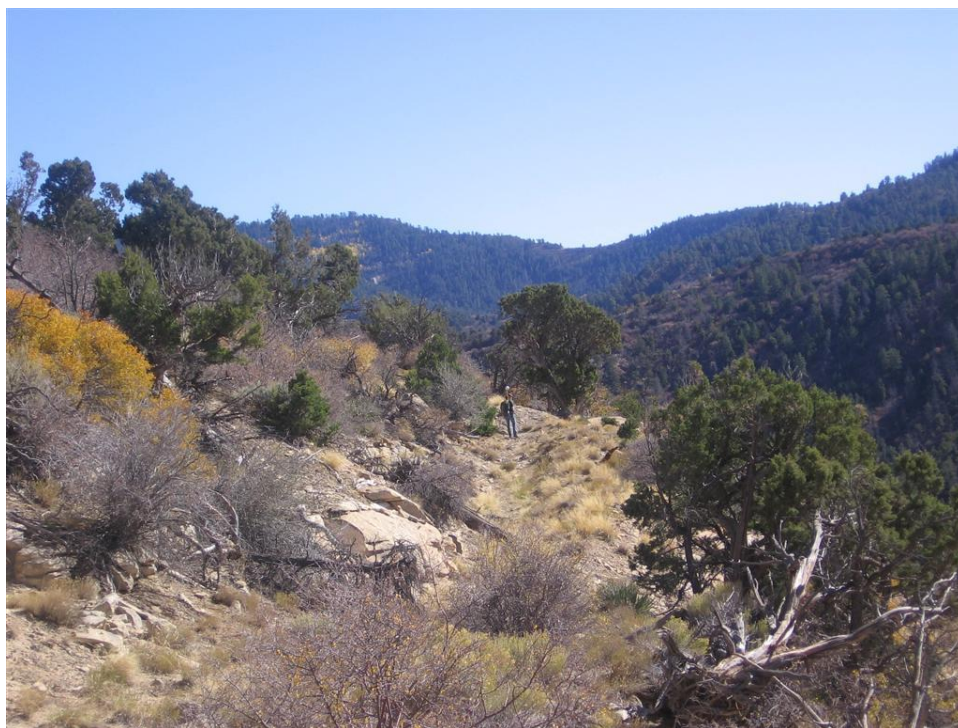
Photo 5. Mine site pathway
